3. EVALUATION OF OU 3-14 CONTRIBUTING SOURCES

3.1 OU 3-14 Soil Contamination Sites

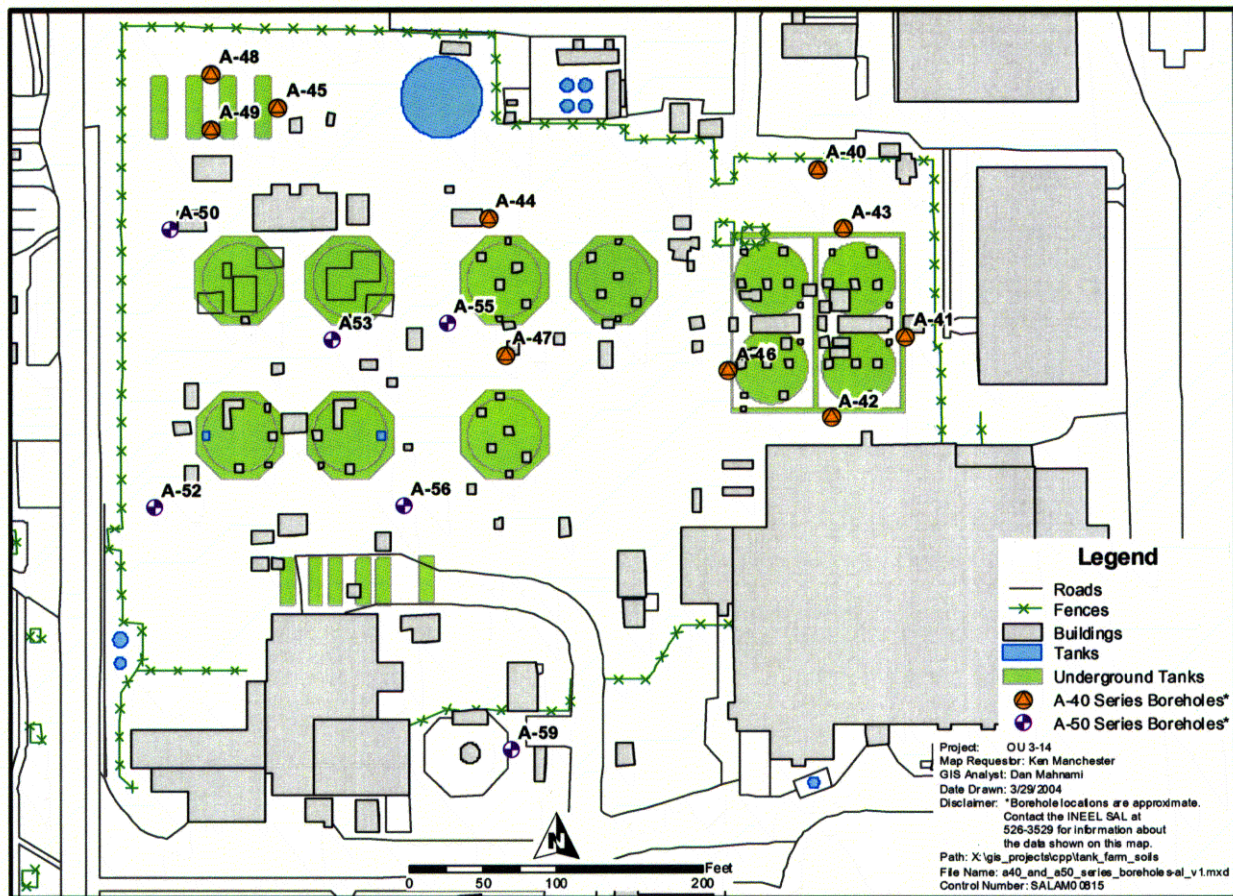
Figure 3-2. Locations of the A-40 and A-50 series wells installed in 1973 and 1975, respectively.

In September 1973, 10 monitoring wells (A-40 through A-49) (Figure 3-2) were drilled and installed by the United States Geological Survey (USGS) at various locations in and around the tank farm as part of an effort to learn how water was entering the vaults of certain waste storage tanks. Unfortunately, field records for this series of wells were not found and details of the work are not well documented. The holes were drilled to bedrock using an auger rig and cased with 2-in.-diameter aluminum pipe. The bottom 6 ft of pipe were screened to permit shallow perched water to enter the

observation well. It is believed that no contamination was encountered in the drill cuttings during drilling of these wells, based on the fact that unusual occurrence reports were not generated for installation of these wells. In addition, the wells were reportedly logged with a down-hole gamma detector resulting in no indication of contamination, but no gamma logging results could be located. As of 1993, wells A-40, -41, -42, -43, and -47 have been either destroyed or removed.

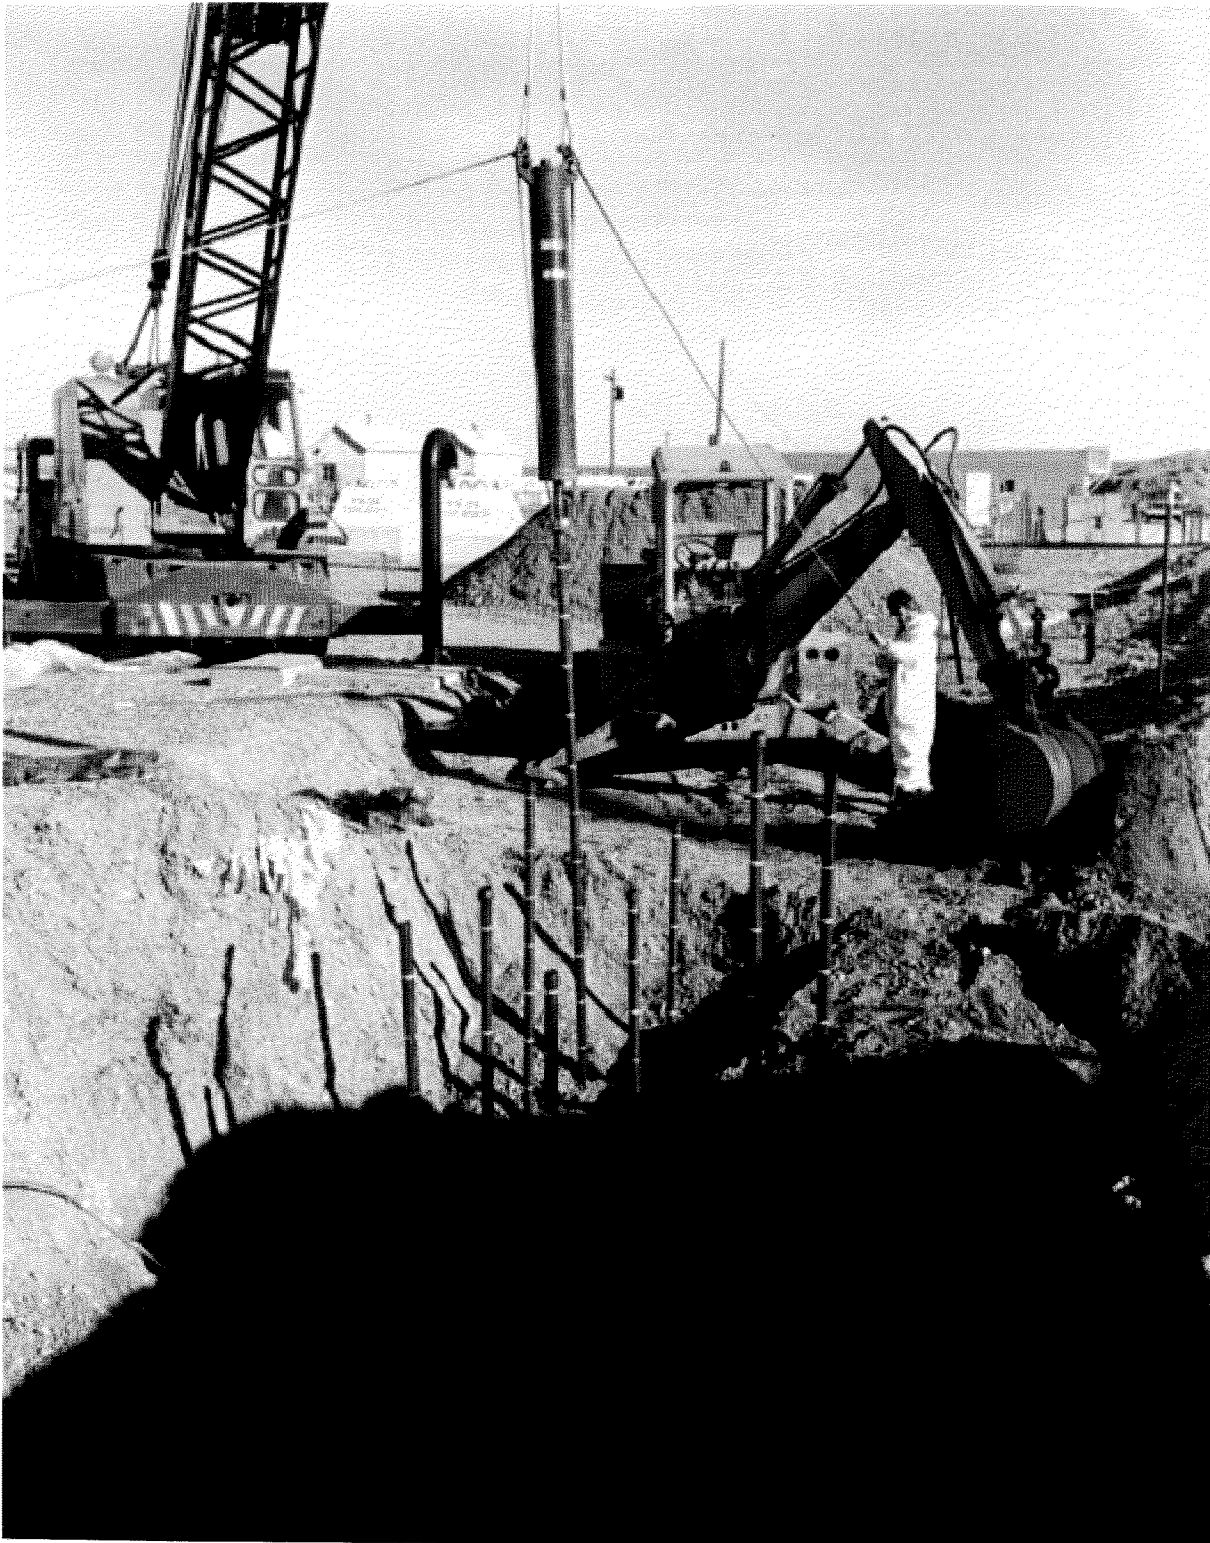
Figure 3-13. Test pipes being driven into the ground during the contaminant release investigation in 1974 at CPP-28.

After trenching operations were completed, monitoring test pipes were driven into the ground using a cable crane rig outfitted with a 750-lb drive shoe (Figure 3-13). Test pipes were driven in 11 locations adjacent to the pipeline encasement and in the area of soil contamination to depths up to 20 ft, as shown in Figure 3-12. After each test pipe was driven, a radiation-detection probe was lowered into the test pipe, and radiation readings were measured at specific depth intervals. Recorded radiation readings collected from the test pipes are presented in Table 3-4.

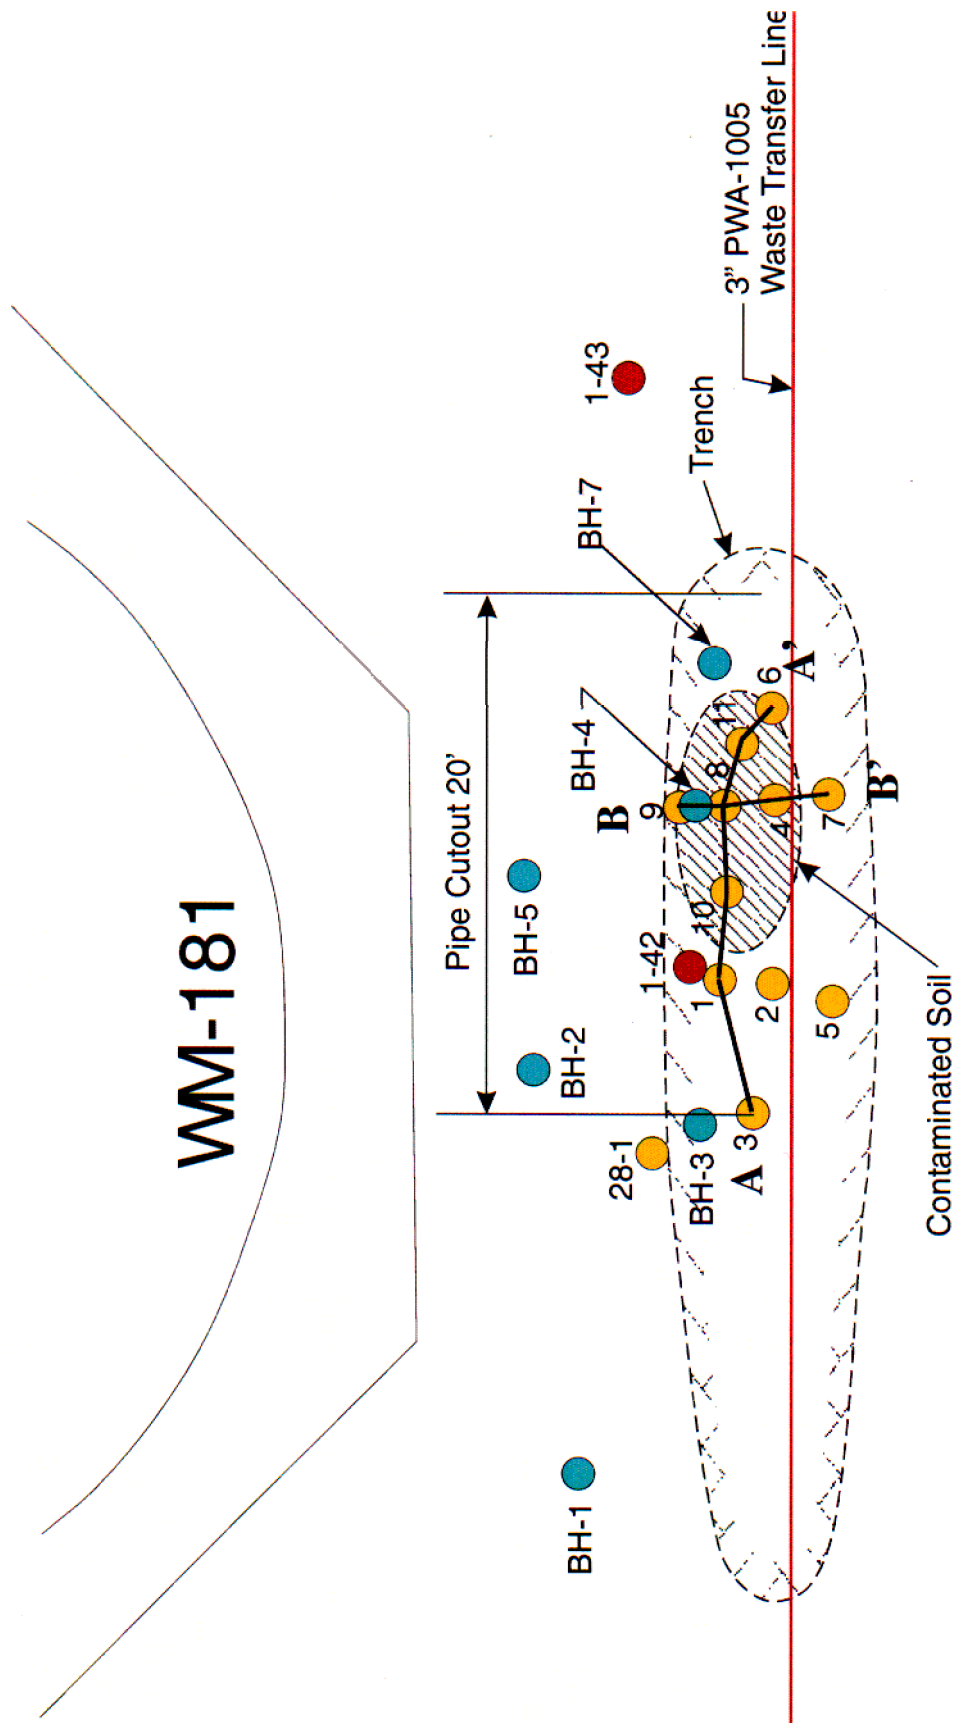
Figure 3-15. CPP-28 fence diagram location map.

From the data provided by the 11 test pipes, the zone of soil contamination was estimated to be approximately 9 ft in diameter by 2 to 3 ft in average depth below the pipe encasement at a depth of 7 ft bgs (Figures 3-15 through 3-17). Calculations made during the investigation estimated that approximately 128 ft³ of contaminated soil existed at the site and the amount of contamination remaining was around 3,000 Ci. The calculations were based on the following assumptions:
